CARMEL CLAY PARKS LIFE-CYCLE ASSET MANAGEMENT PLAN

December 2018

LIFE-CYCLE ASSET PLAN

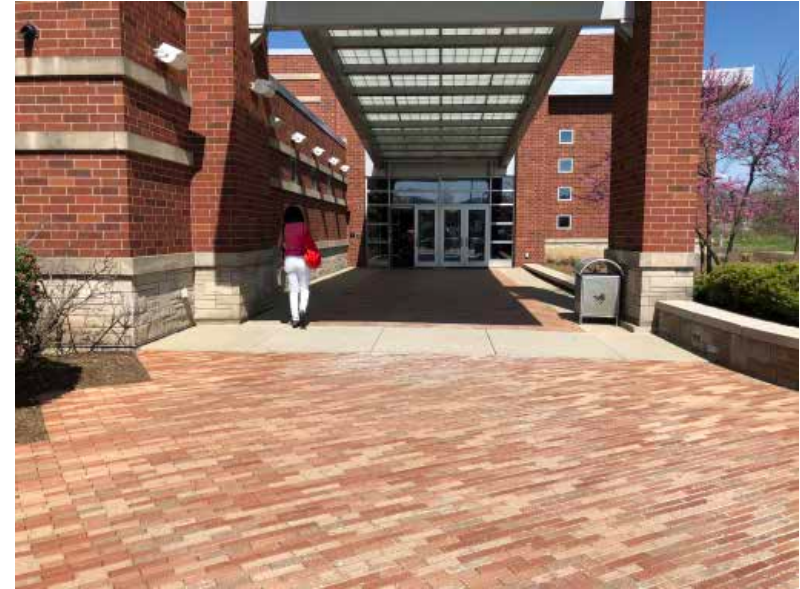
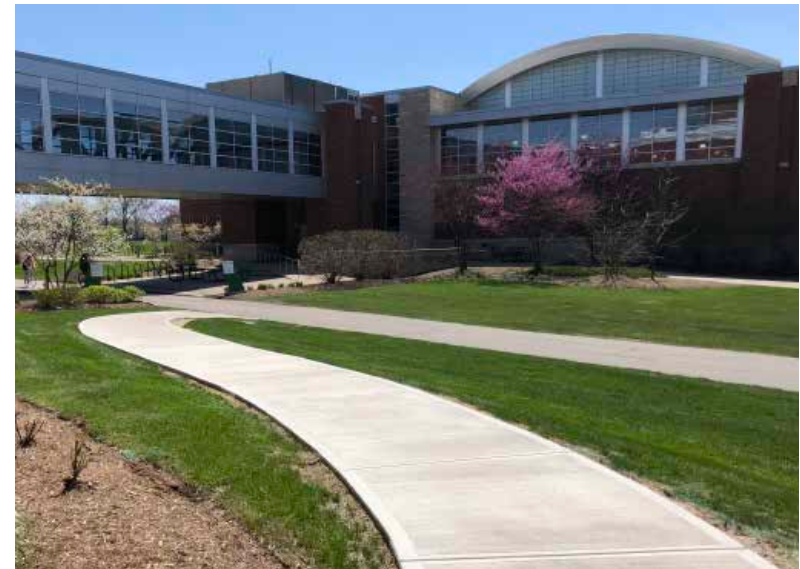
SITE ANALYSIS - MONON COMMUNITY CENTER BUILDING ENVELOPE

The Building Envelope at the Monon Community Center is in good condition, exceeding expectations with continued maintenance. The following summarizes observed conditions that will require attention in the future.

- Rusting on the sunshade supports.
- Faded paint on the west building entrance canopy.
- Staining of the limestone is generally visible on the north elevation.
- East Building: Rusting steel on the terrace.
- East Building: Staining of limestone on stair tower.
- East Building: Crack at masonry corner.
- East Building Terrace: Erosion of the concrete subbase on the south side. Immediate remediation is recommended to prevent further deterioration.

- East Building: Terrace drainage erosion under the terrace was observed. Immediate remediation is recommended to prevent further erosion.
- Roofing warranty is near the end. Anticipate replacement in the next 5-7 years.

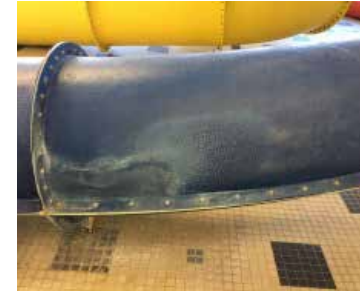
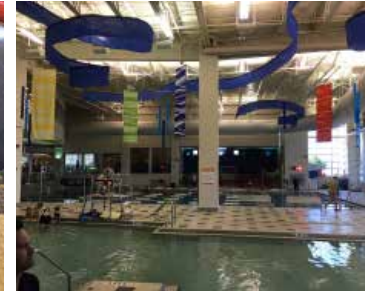
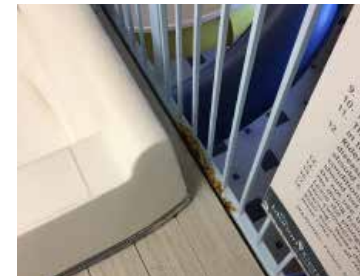
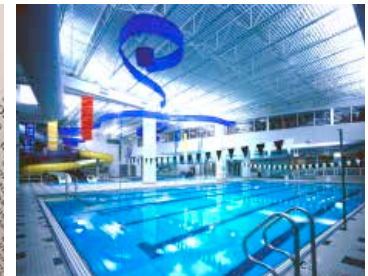
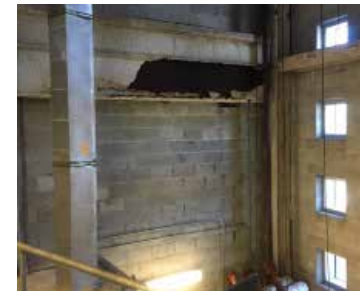
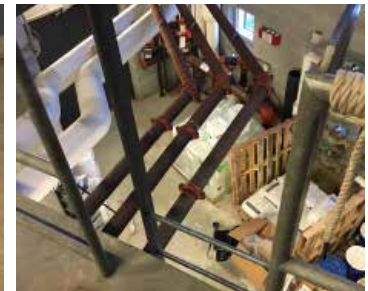
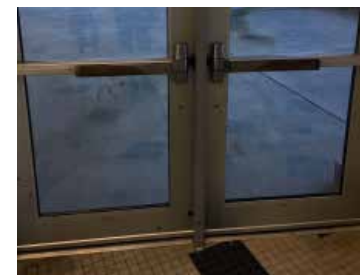
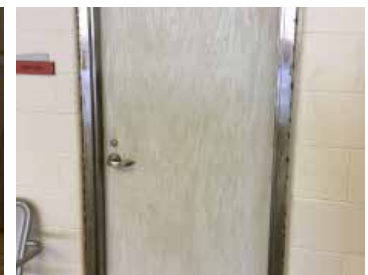
- Aquatics Equipment Room: Excessive rusting was observed in the mechanical space including the structural beam and fire protection piping. Immediate remediation is recommended to prevent further deterioration.
- Natatorium: Excessive rusting/oxidation was observed on the door frames and hardware. Normal maintenance would alleviate the oxidation.
- Natatorium: Rusting was observed on the slide tower railings and support structure.
- Natatorium: Fading of the body flume slides was observed. A re-coating application is recommended.

- Pool systems are generally in good condition, meeting expectations. The UV sanitation has significant rusting on the equipment.
- Aquatic mechanical space is not adequately ventilated. Additional ventilation is recommended.

- Generally, all mechanical units are in good condition, meeting expectations. Normal maintenance has occurred with replacement of units and compressors. Anticipate replacement of rooftop units as they are nearing their life expectancy in the next 3 - 5 years.

- Explore energy saving measures by converting to LED lighting in the facility.
- Explore higher efficiency roof top unit with energy recovery to increase energy savings.
- Explore replacement of sand filters for the aquatics with regenerative media for water savings.

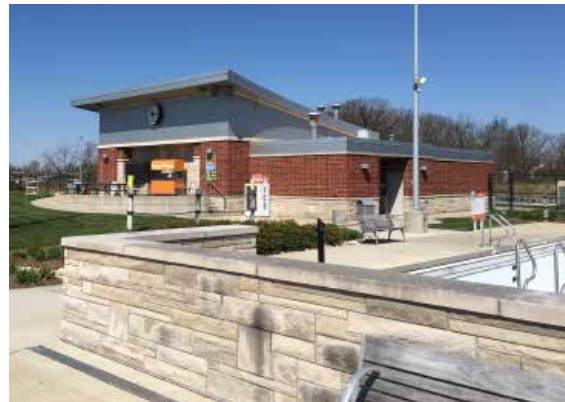
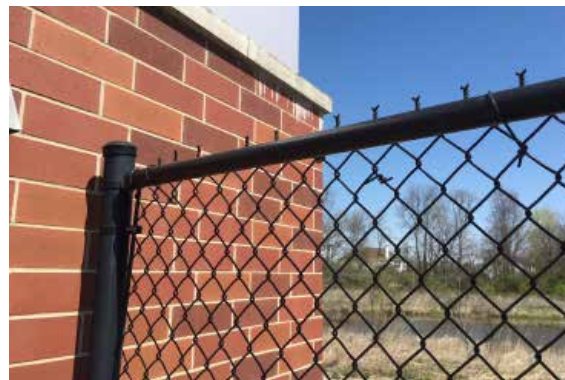
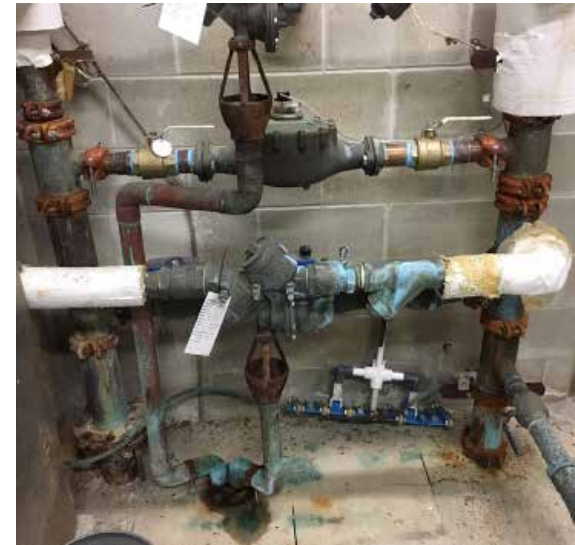
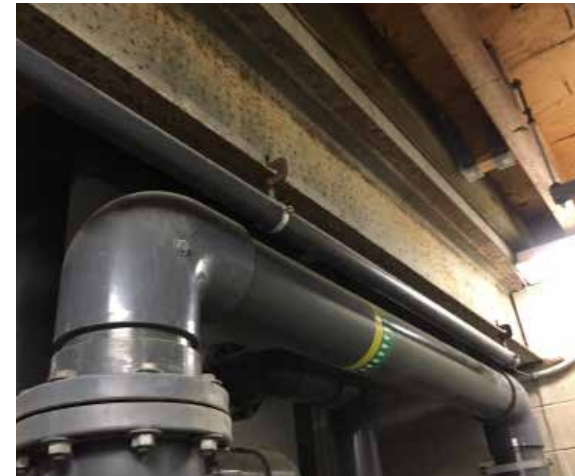
FLOWRIDER FILTRATION BUILDING

- The Main Filtration Building is in good condition, exceeding expectations with continued maintenance. Constructed in 2005.
- Rusting of steel beams was visible due to the corrosive environment.
- The limestone has staining with efflorescence on the brick.
- The PVC roofing is presently under warranty. Replacement is expected within the next 10 years.
- Rusting was observed on the incoming water service due to the corrosive environment.
- Filtration system of pool requires replacement due to meeting life expectancy. Explore replacement of sand filters at the Waterpark with regenerative media for water savings.

- The brick has efflorescence on the exterior.

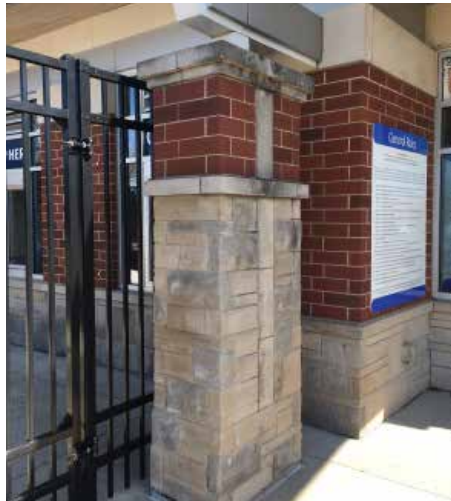
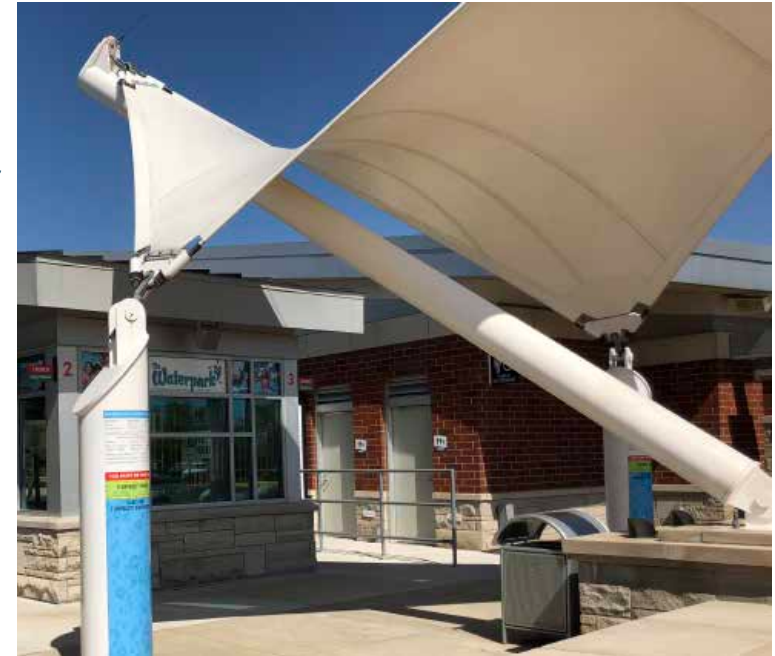
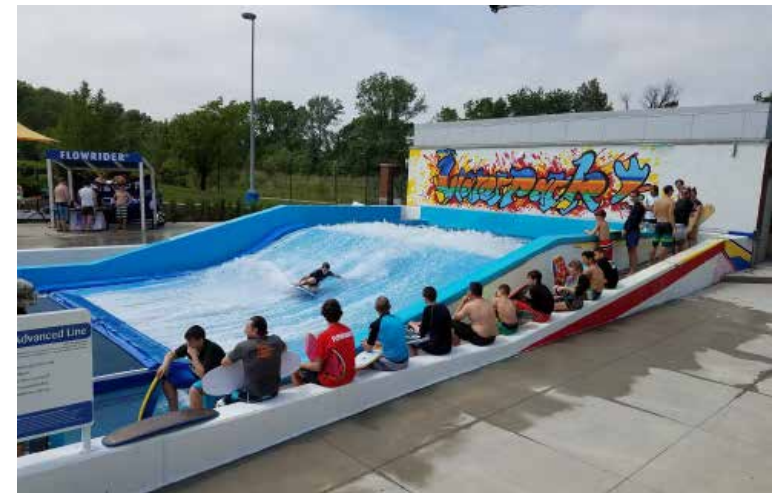
WATERPARK FEATURES

- The Entry Control Building is in good condition, exceeding expectations. Completed in 2005 with a modification in 2015.
- The exterior building envelope has staining on the limestone.
- The HVAC and condensing unit in the concession were installed in 2017.
- The PVC roofing is presently under warranty, replacement is anticipated within the next 10 years.

- The plunge area for a future tube slide does not have filtered water. Remediation may be required if an additional slide is provided.
- The filtration system on the Flowrider requires normal maintenance.

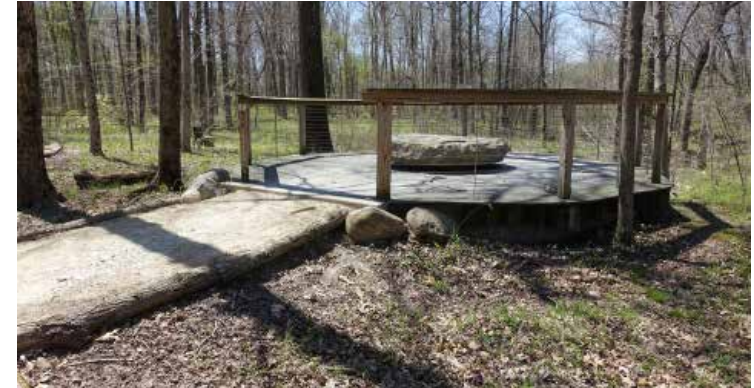
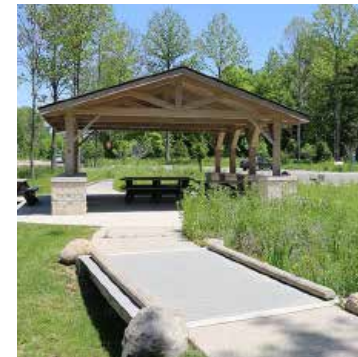
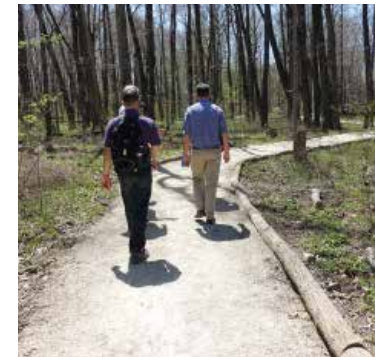
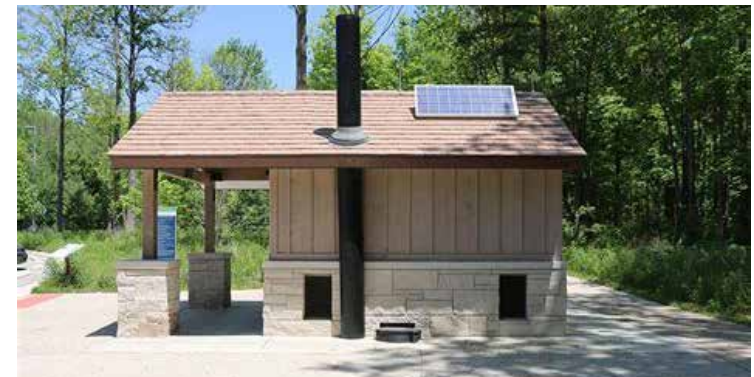
SITE ANALYSIS - EAST WOODS

- Carmel Creek is a unique attraction.
- Understory vegetation north of the roadway is well-maintained, native vegetation.
- Formalized log trail helps define the pedestrian space.
- Timber guardrails and specialty pavement in roadways along Central Park Drive East enhance the sense of place and help regulate vehicle speeds.
- Picnic grove shelters are well utilized.
- Trex boardwalks are aesthetically pleasing and individual planks are easily replaceable by park staff.
- The east grove shelters are in good condition and meets expectations with continued maintenance.
- The exterior restrooms are in good condition and exceed expectations with continued maintenance.

- Improve drainage from the Central Park Drive to the east woods.
- Consider removal of central bench from boardwalk nodes where possible to improve circulation for maintenance vehicles.
- Monitor log curbs along trail to prevent exposed rebar and remove curbing that blocks access to benches and signage.
- The cedar shingles roofing on the shelter is nearing the warranty period. Anticipate a replacement in the next 8 to 10 years. Staining was observed at the base of the limestone.
- The solar panels on the exterior restroom are nearing the end of their life cycle. Anticipate replacement in the next 8-10 years.
- The cedar shingle roofing on the exterior restroom is nearing the warranty period. Anticipate replacement in the next 8-10 years.

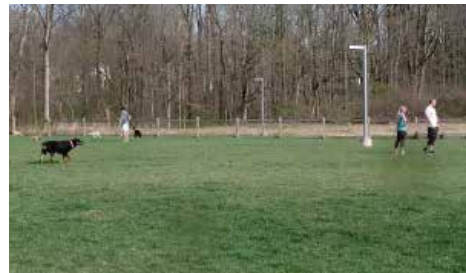
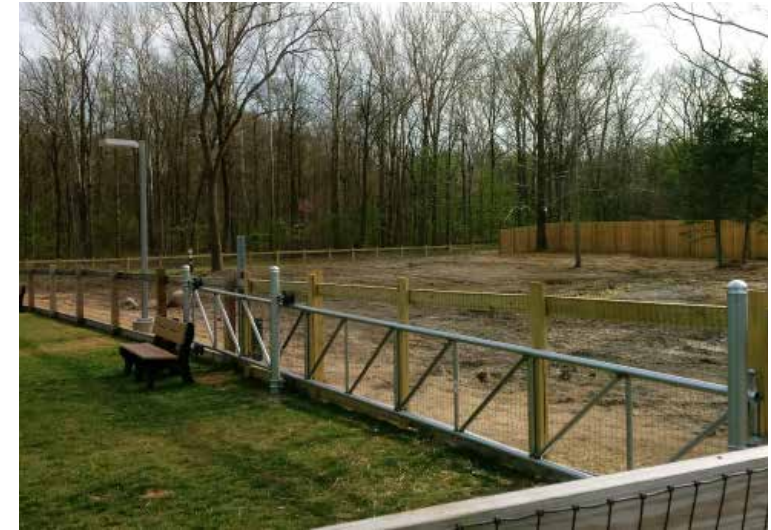
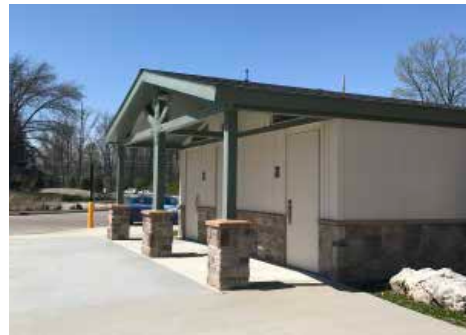
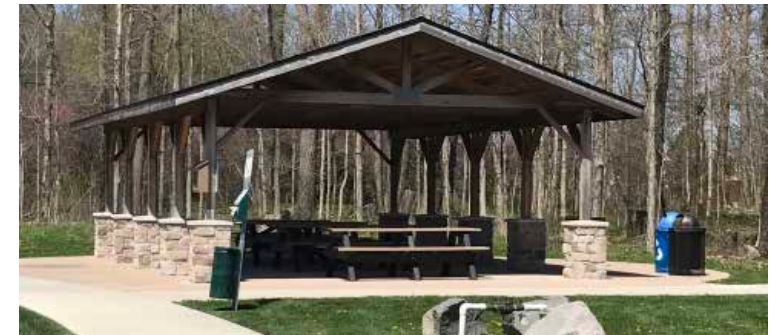
SITE ANALYSIS - DOG PARK

- The dog park is heavily used. Currently there is a waiting list for users. Expansion currently under construction will help meet the demand by community members.
- Parking lot utilizes permeable parking.
- Flexible use lawn, picnic shelter, and restrooms adjacent to dog park.
- The Dog Park shelter and exterior restroom are in good condition, exceeding expectations with continued maintenance. These structures were recently completed in 2017.

- Look to incorporate dog parks in other areas of Carmel-Clay park system.
- Rust staining was observed on the shelter stone due to iron deposits in the irrigation well water.

- Create trail connection to the main area of Central Park.
- Improve vehicle entrance to parking area. The existing turning radii is tight for most vehicles.
- Attach utility box to restroom facility and cover well utility structure.
- Overseed dog park lawn with fescue to establish a deeper-rooted turf system.

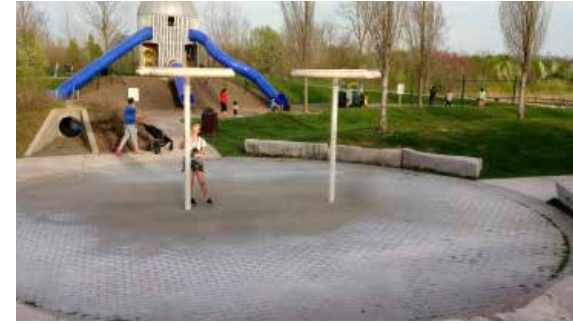
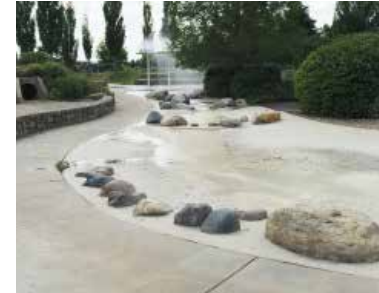
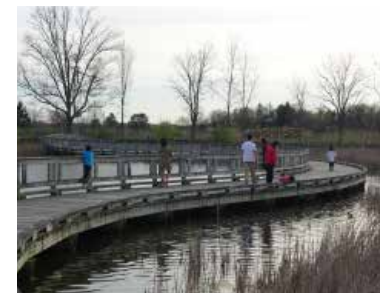
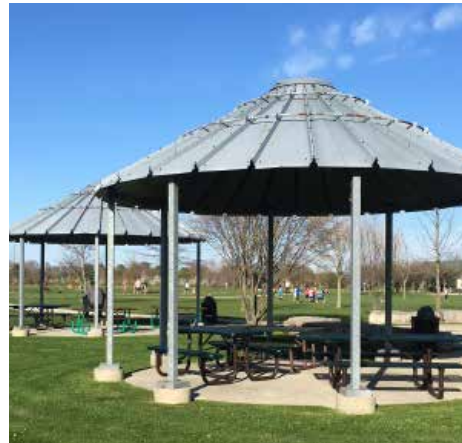
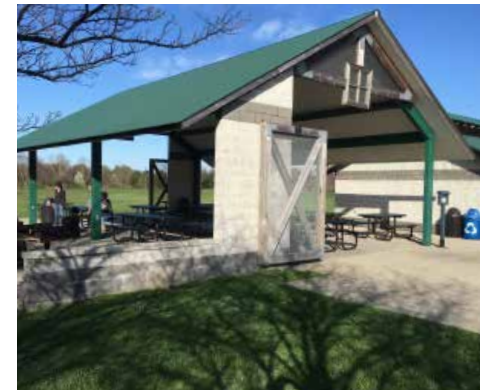
- Heavily utilized as the only western park in the system.
- Large amount of program amenities including a pond with boardwalks, playgrounds, splashpad, amphitheater, rentable shelters, open lawn, and looped trails.
- Diverse natural systems such as wetlands, prairies, and forests.
- Currently in the process of updating features following the current park master plan.
- The circular shelters are in fair condition, marginally meeting expectations.
- The large shelter is in fair condition, marginally meeting expectations.
- The exterior restrooms are in good condition, meeting expectations with continued maintenance.
- The splashpad is in fair condition, marginally meeting expectations. The features of the splashpad have exceeded their life expectancy.

- Continue implementing the current park master plan.
- Explore the feasibility of a community center for west Carmel.
- The column bases and snow guards on the circular shelters are rusting.
- The cedar soffits are deteriorating at the large shelter. The masonry walls have excessive efflorescence and the metal roof has signs of rusting. Remediation may be required.
- The cedar structure is partially deteriorating at the exterior restrooms. Efflorescence is visible on the masonry.

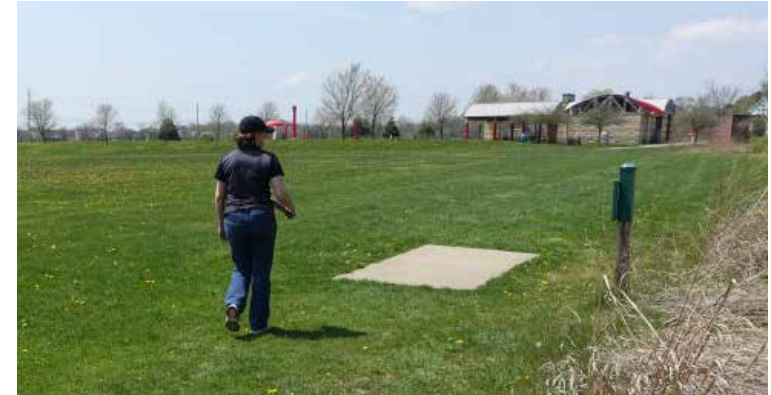
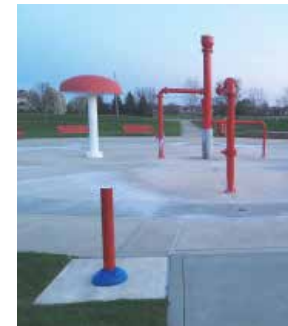
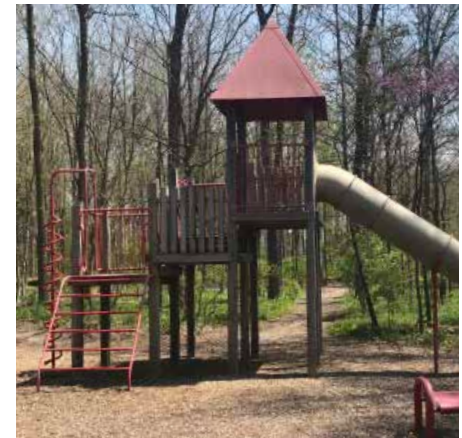
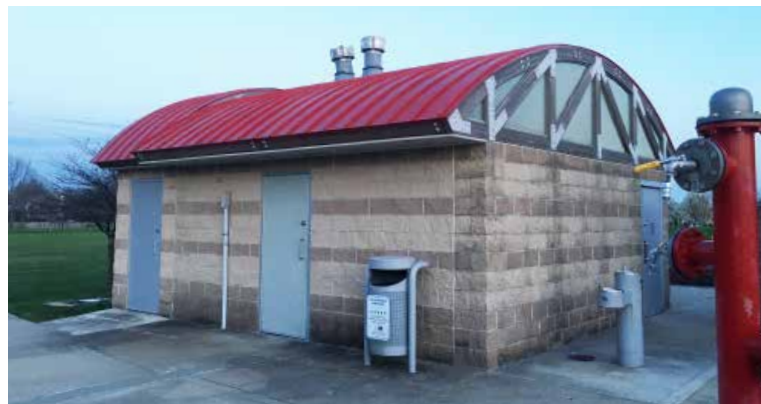
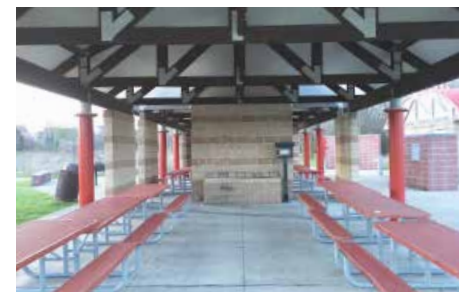
- Large community park with a diverse program including sheltered picnic space, splashpad, disc golf, playgrounds and forested trail.
- Currently in the design process of updating playground and splashpad spaces.
- Large unprogrammed lawn space.
- The shelter was completed in September 2000 with an expansion in 2003. The structure is in good condition and meets expectations, with continued maintenance.
- The exterior restrooms were completed in September 2000. The building's structure, systems and interior are well maintained and in good condition, but lack the ability to heat, limiting use to warm months. The building meets expectations, provided continued maintenance.
- The splashpad was completed in September 2000. The splashpad is in fair condition, marginally meeting expectations. The features of the splashpad have exceeded their life expectancy.

- Improve drainage around berm in lawn space to simplify park infrastructure. Aerial drains are currently required to drain lawn.
- Replace park amenities per the updated plans.
- The cedar structure at the shelter and exterior restrooms is weathered with some splitting timber and rusted connections. Remediation may be required.
- Replacement of the splashpad may be considered to improve the recreation experience and sightlines with the playground. Recommendation to provide a more interactive application.

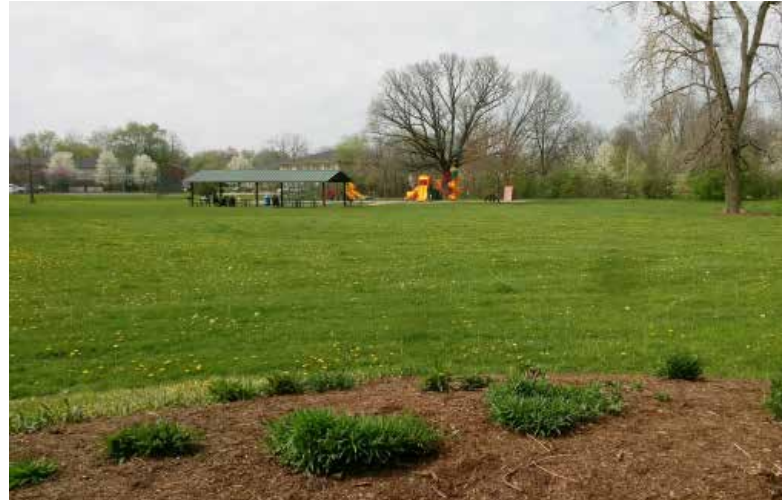
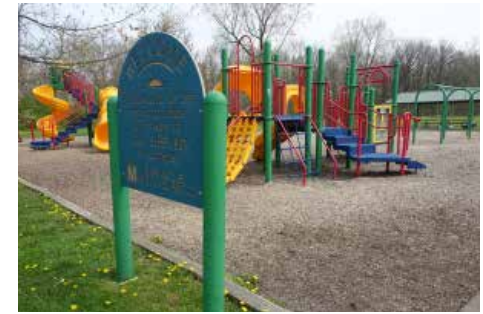
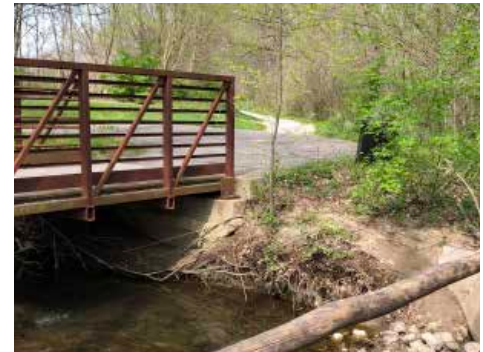
SITE ANALYSIS

- Neighborhood park with proximity to the downtown Arts and Design District and Monon Greenway.
- Park amenities include: basketball court, playground, picnic shelter, pond with fishing pier and unprogrammed lawn spaces.
- The shelter is in fair condition, meeting expectations with continued maintenance.

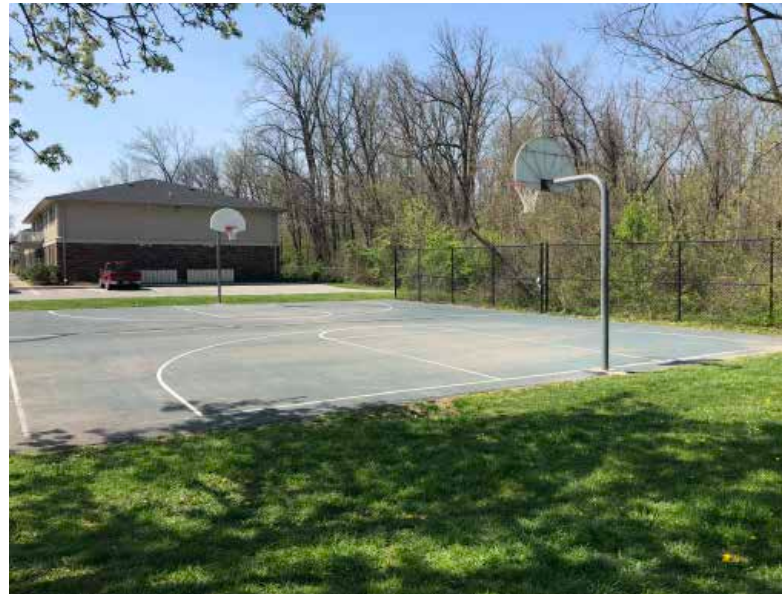
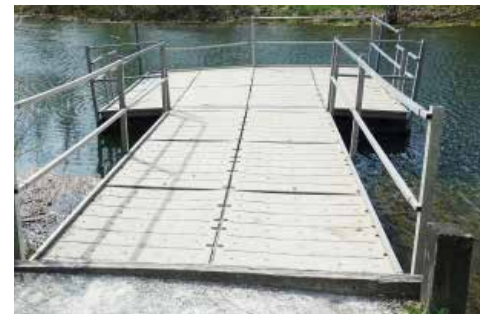
- Facilities are generally outdated. A new master plan should be completed prior to replacement, including a wetland delineation as part of the planning process.
- Relocate playground and shelter out of floodplain.
- Stabilize bridge abutments.
- Fishing pier is failing. Replace with ADA accessible pier. Grant funding may be available.
- Minor rusting was observed on the shelter, including metal roofing fasteners and structure.

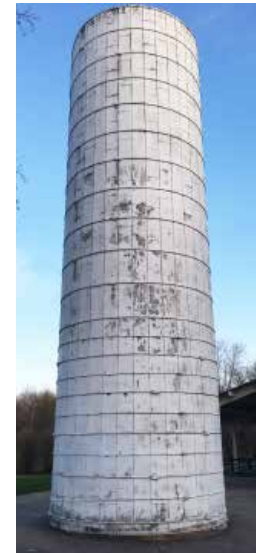
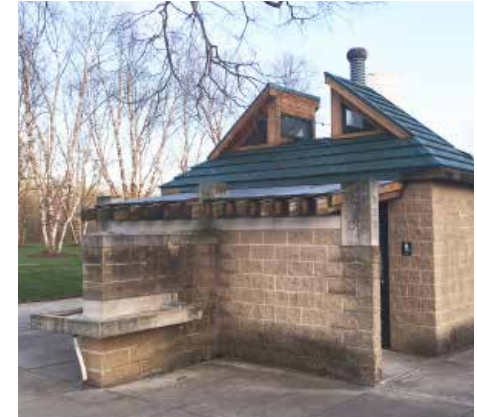
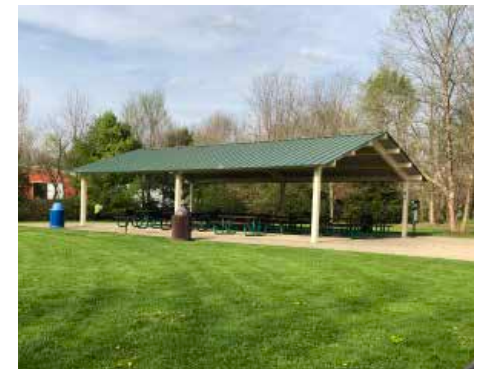
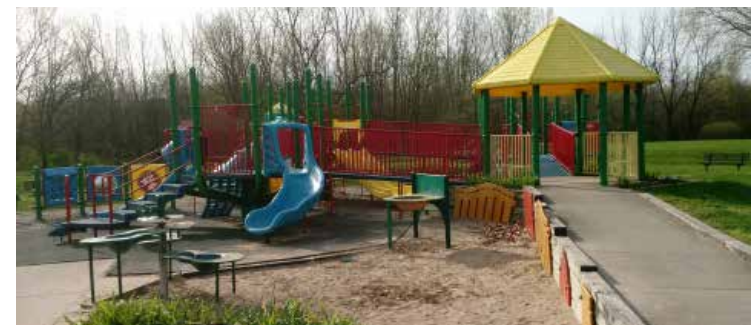
- Playground area and rentable shelter are popular destinations for park visitors.
- Volleyball courts are programmed frequently.
- Forested area fronts the White River.
- The shelter is in fair to good condition, meeting expectations with continued maintenance.
- The exterior restroom are in good condition, meeting expectations with continued maintenance. Restroom lacks heat for winter use and has no interior sinks.
- The silo is original to the site, a historic remnant from farming usage. The silo is constructed of concrete strapped panels, and appears structurally sound except for peeling paint.

- Facilities are generally outdated. A new master plan should be completed prior to replacement, including a wetland delineation as part of the planning process.
- Revise the grading plan to remove grassed berms which are difficult to maintain.
- Improve visual connectivity to White River.
- Create a trail connection to Founders Park.
- Consider permeable paving when replacing the current gravel lot.
- The shelter structure's paint is poorly applied, requiring reapplication.
- The cedar structure at the exterior restroom is aging, demonstrating water damage.
- The masonry walls at the exterior restroom are stained at the base with areas of efflorescence. General cleaning would remediate the issue.

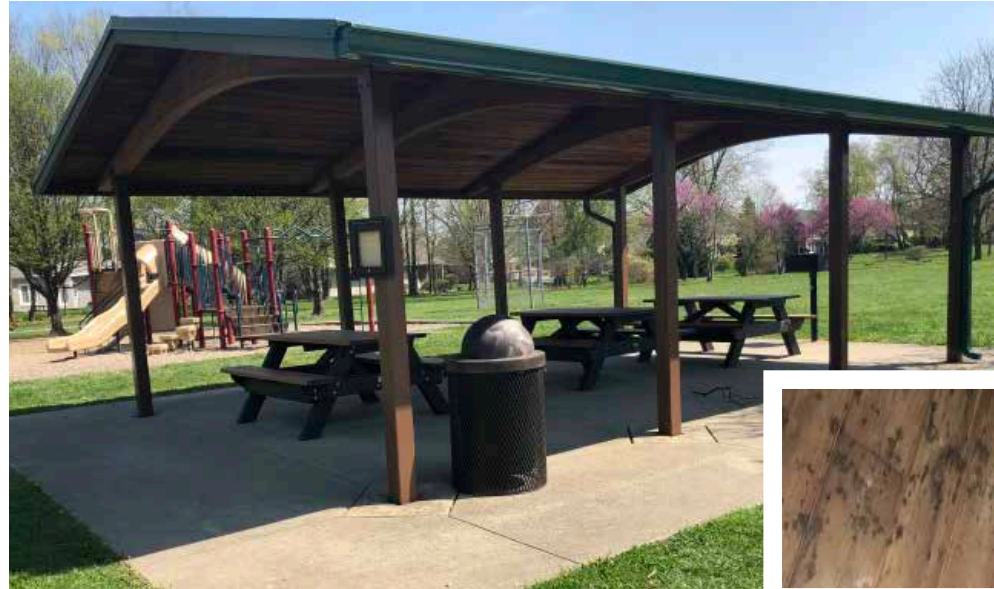
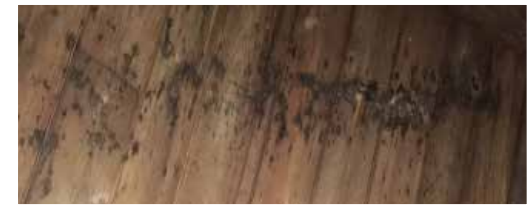
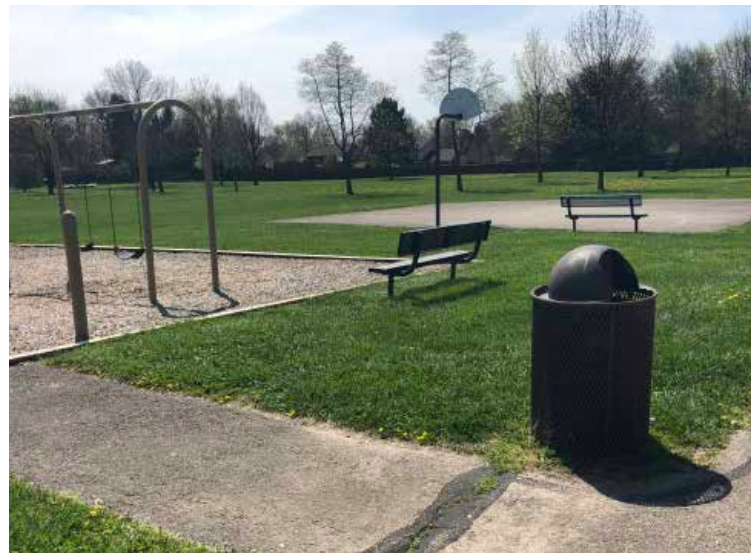
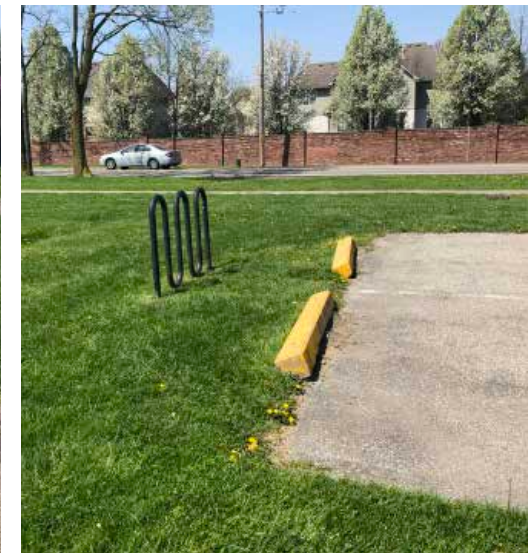
- Mature canopy trees.
- Includes a variety of programmed spaces.
- Looped trail provides access around the perimeter.
- Shelter is structurally stable and in good condition with minor water stains on the cedar decking.

- Facilities are generally outdated. A new master plan should be completed prior to replacement.
- Resurface parking lot and trails and reset wheel stops.
- Improve accessibility to the bike racks and drinking fountain.
- Update entrance signage to current standard.
- Replace aging park amenities such as the waste and recycling bins, benches and playground.

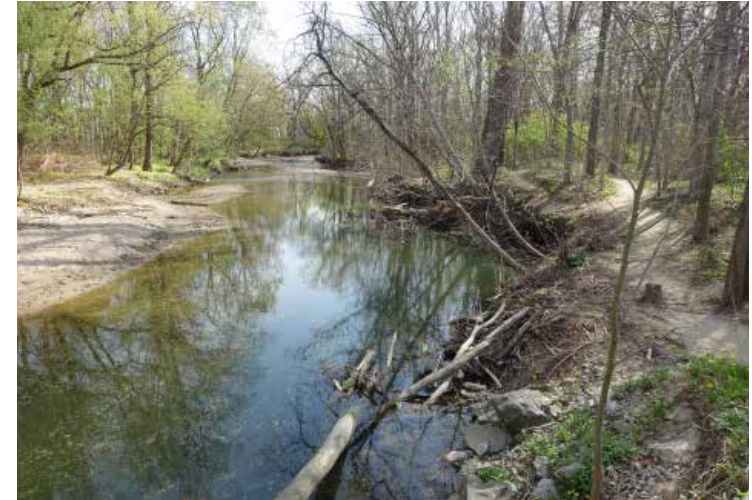
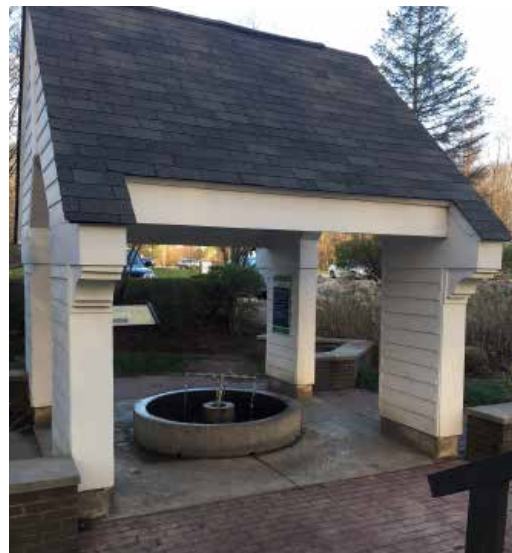
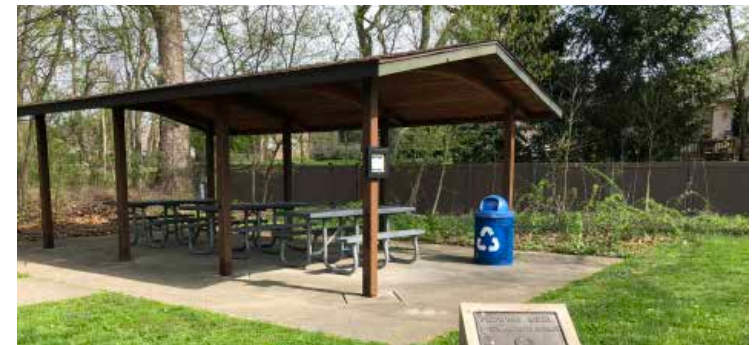
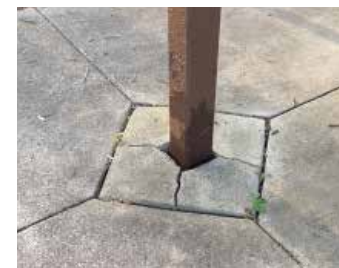
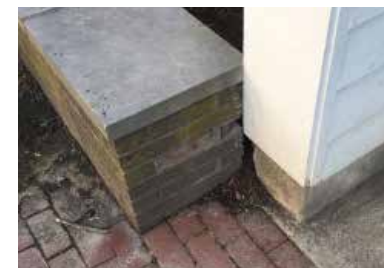
- Artesian spring is popular attraction for community members. Bottling of spring water is a common occurrence.
- Natural trails along creek are well used and do not require surfacing. Bridges are in good condition
- Sand beaches along creek are unique attractions during summer months.
- Well structure is a well maintained aging wood frame, meeting expectations.
- The well pump is operational, requiring normal maintenance.
- Picnic shelter structure is in fair condition, meeting expectations. The wood roof structure is aging.

- Significant erosion of outer stream banks requires attention within the near future.
- Improve space surrounding the well and pedestrian access to limit cutting through landscape beds.

- Update entrance signage and trail map. Replace existing weathered interpretative signage throughout park.
- Anticipate a roofing replacement for both the well structure and shelter in the next 1-3 years.
- Remediation of masonry seat wall at well structure is warranted.
- Regular maintenance is required on the structural steel at the shelter. Rusting was observed.

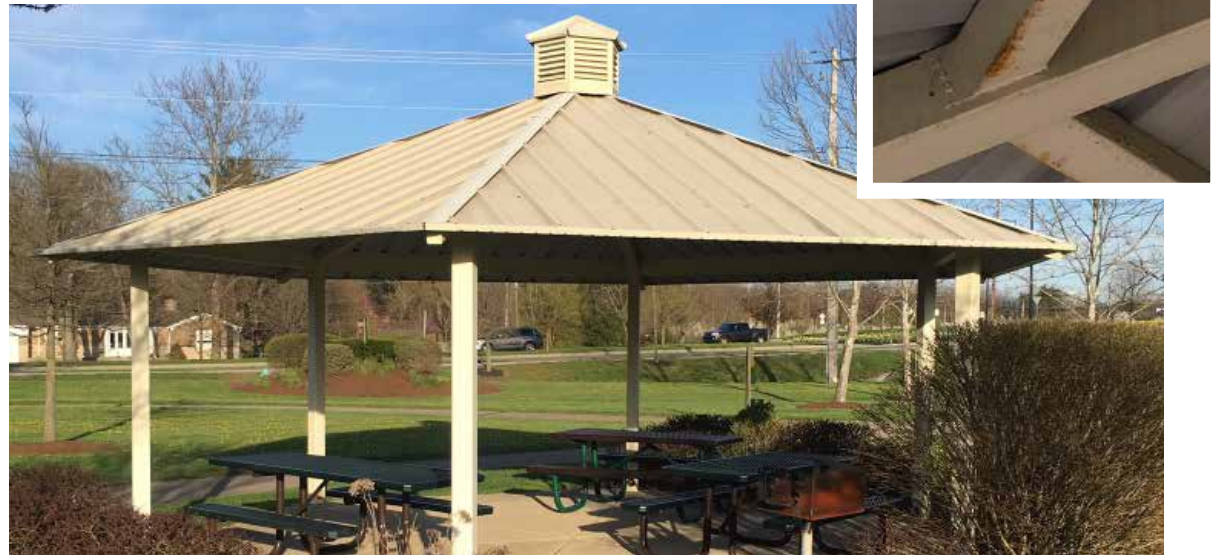
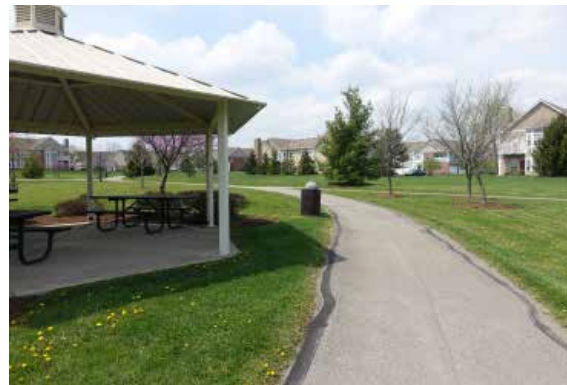
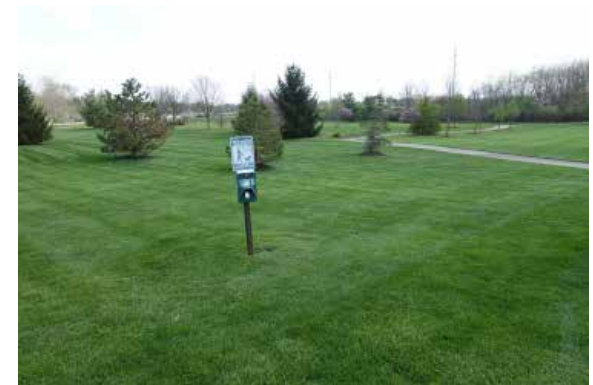
- Large open lawn space.
- Trail system through park connects to the adjacent Monon Greenway.
- The shelter is in good condition and meets expectations.

- Extension of 96th Street will affect the southern edge of the park. Synchronize park improvements with anticipated restoration from highway infrastructure project.
- Improve signage to existing parking lot within the adjacent neighborhood development. Current signs create appearance that there is no public access to the park.
- Minor rusting was observed on the structural steel at the shelter.

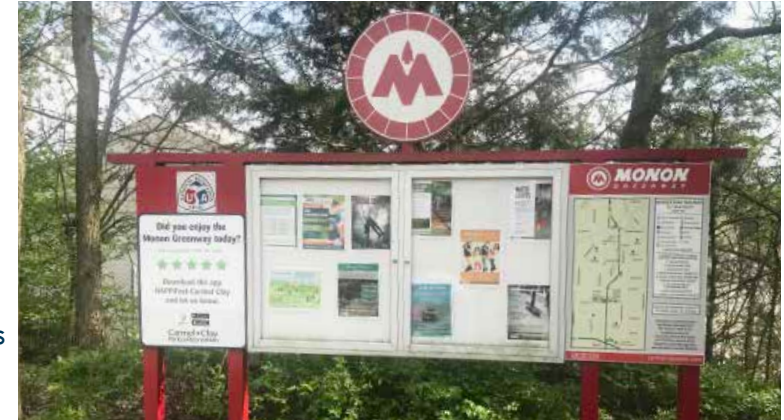
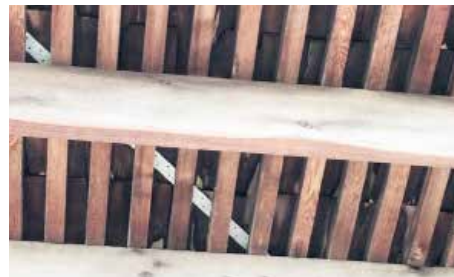
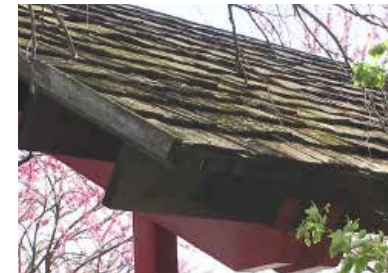
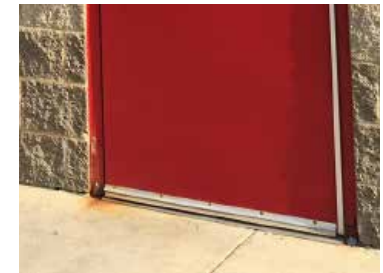
- Free parking is provided at each trailhead, as well as Carmel City Hall.
 - Clear signage and visual connection to trailhead from adjacent roadways.
 - Restrooms, drinking fountains, bike repair stations, and benches are provided at each trailhead.
 - Trailheads are well spaced along the greenway within the community.
 - The exterior restrooms were completed in January 2004. The structures are in good condition and exceed expectations with continued maintenance.
 - The shelter at the south trailhead is in fair condition, marginally meeting expectations.
- Minor staining was observed on the limestone base of the exterior restrooms at the north trailhead.
 - Rusting was observed on the doors of the exterior restrooms at both trailheads.
 - The roofing at the south trailhead shelter requires replacement. Severe rotting of the wood roof was observed.

- Improve connectivity to the Monon Greenway from downtown Carmel. Improve signage from intersecting roadways.

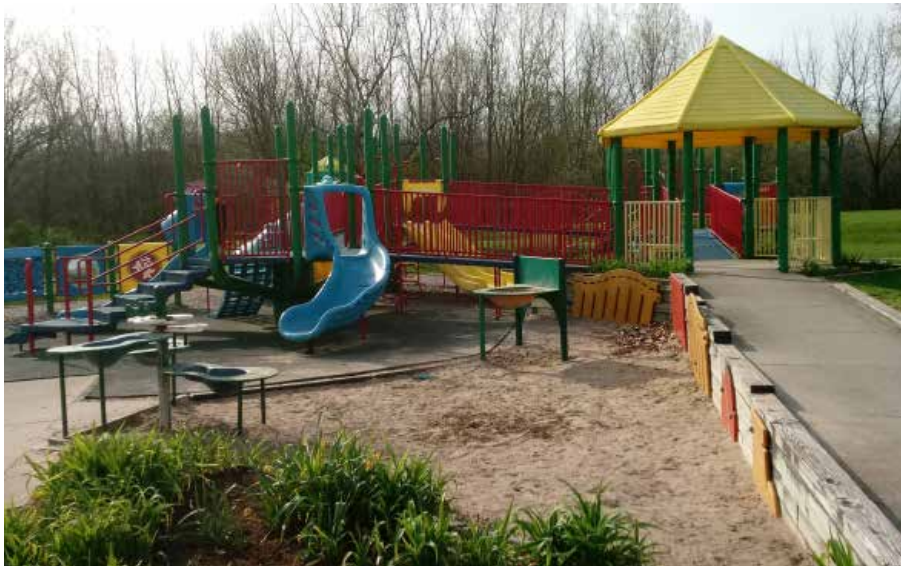
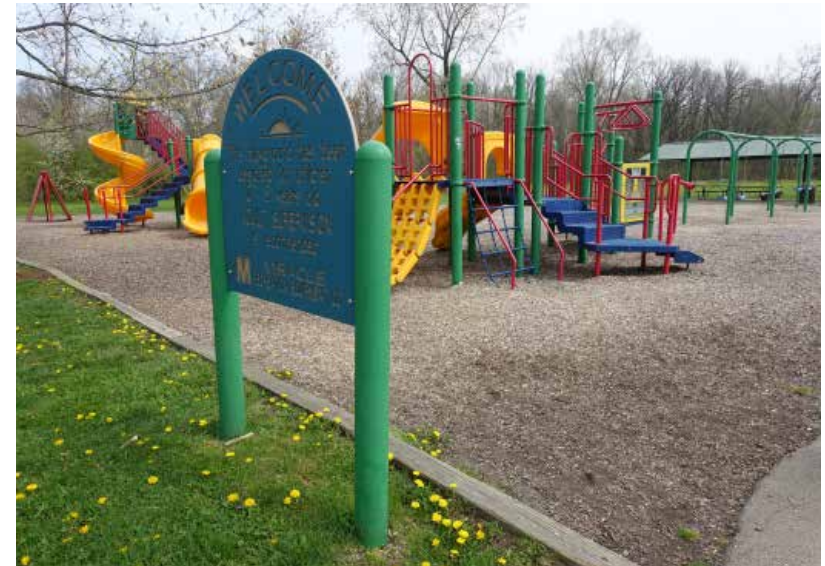
Bridge repairs comprise a large portion of the forecasted capital replacement projects prior to 2020. A significant number of these repairs are for bridges on the Monon, Greyhound, and Hagan Burke Trails, as noted in the 2018 *Structure Inventory and Appraisal Reports* issued by the City of Carmel Department of Engineering. This report did not provide overall asset values for all bridge structures, only repair costs recommended before 2021. The asset management spreadsheet includes the repair costs noted by the study, including the full replacement of the Monon Greenway bridge over Little Cool Creek. However, given that the total cost to replace the remaining bridges is unknown at this time, the spreadsheet does not include full values for these structures.
