CARMEL CLAY PARKS LIFE-CYCLE ASSET MANAGEMENT PLAN

December 2018

LIFE-CYCLE ASSET PLAN

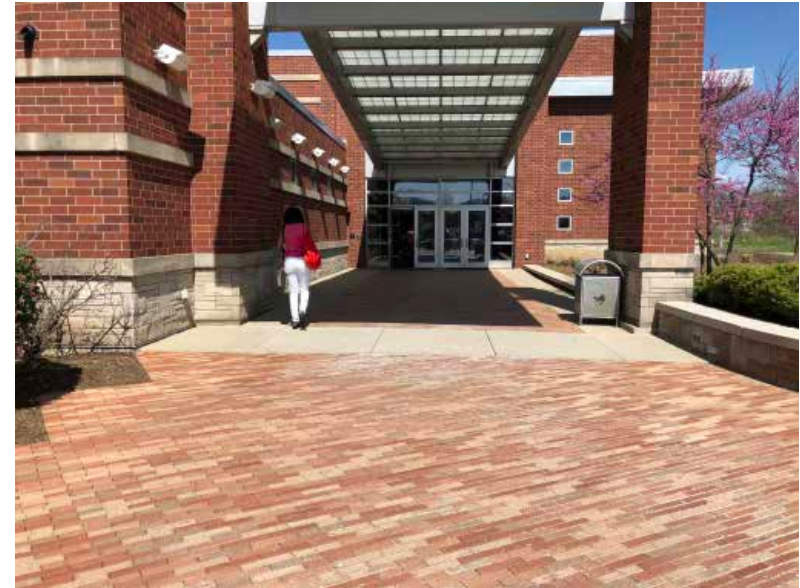
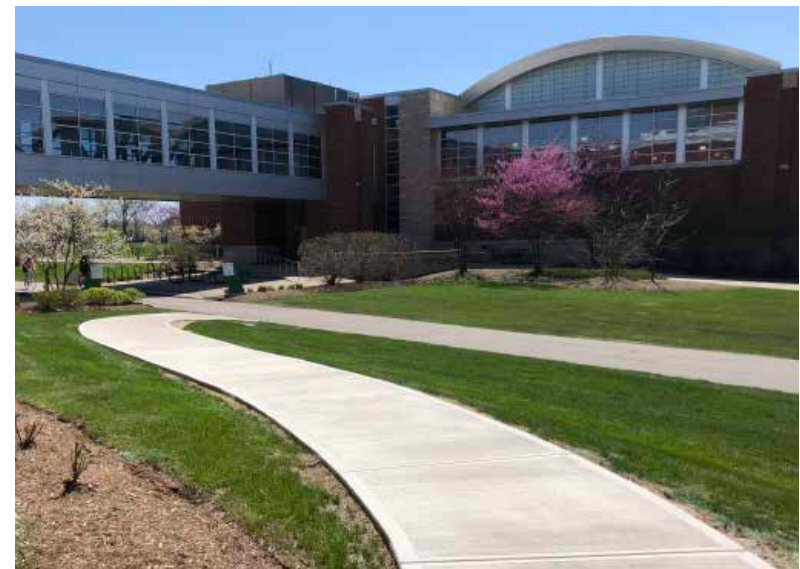
- Park wide lighting updated in Spring 2018.
- Newly resurfaced Monon Greenway is in good condition.
- Sloped lawn south of Monon Community Center is utilized by recreation programs and summer camps.

- Reset paving and bollards or explore alternative circulation control devices.
- Reset or replace brick and concrete pavement that is beginning to fail.
- Identify funding source for skate park bowl replacement.
- Replace rusting bike racks along the Monon Greenway.
- Improve drainage along the staff parking entrance drive to prevent further erosion.
- Expand entrance traffic circle to improve large vehicle circulation.

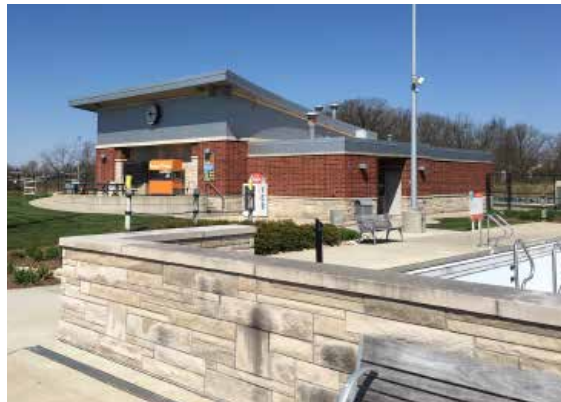
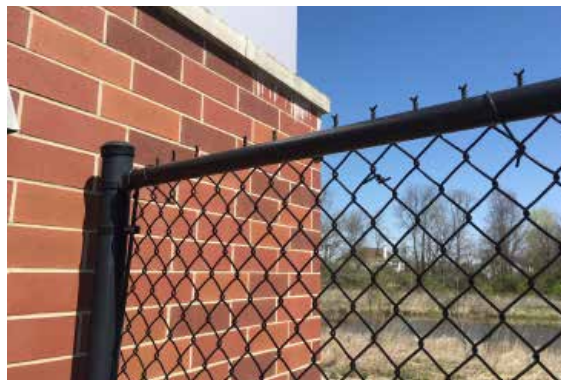
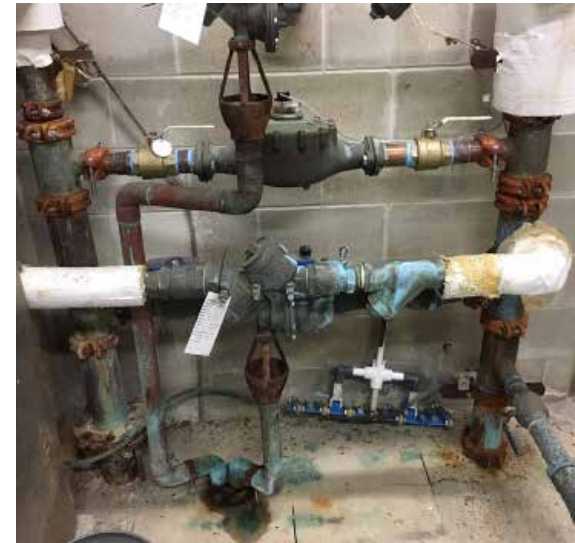
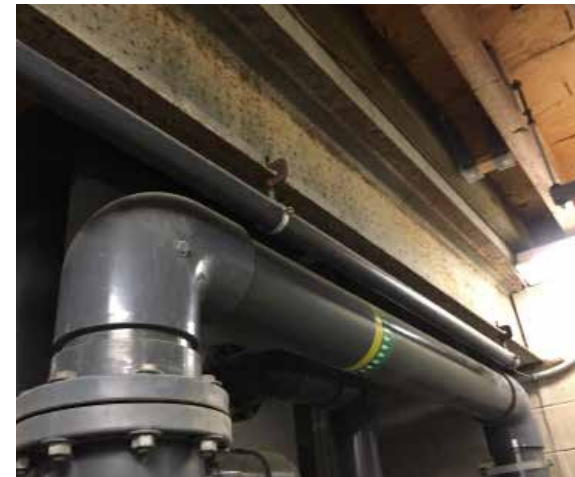
SITE ANALYSIS - MONON COMMUNITY CENTER

- Aquatics Equipment Room: Excessive rusting was observed in the mechanical space including the structural beam and fire protection piping. Immediate remediation is recommended to prevent further deterioration.
- Natatorium: Excessive rusting/oxidation was observed on the door frames and hardware. Normal maintenance would alleviate the oxidation.
- Natatorium: Rusting was observed on the slide tower railings and support structure.
- Natatorium: Fading of the body flume slides was observed. A re-coating application is recommended.

- Pool systems are generally in good condition, meeting expectations. The UV sanitation has significant rusting on the equipment.
- Aquatic mechanical space is not adequately ventilated. Additional ventilation is recommended.

- Explore energy saving measures by converting to LED lighting in the facility.
- Explore higher efficiency roof top unit with energy recovery to increase energy savings.
- Explore replacement of sand filters for the aquatics with regenerative media for water savings.

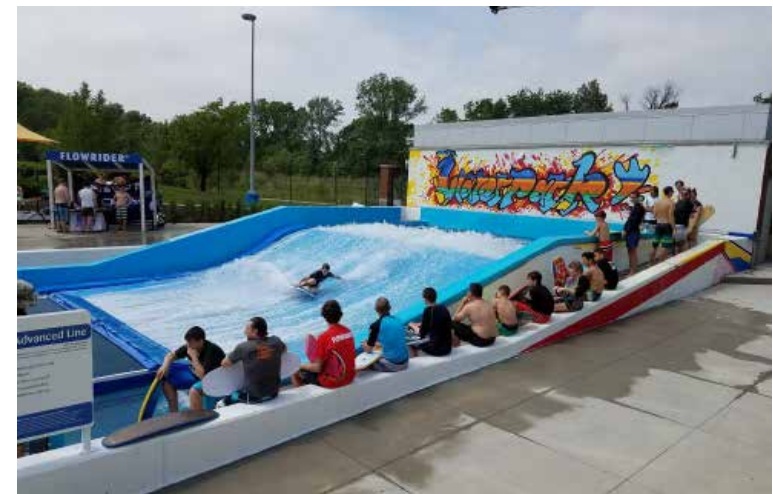
WATERPARK FEATURES

- The Waterpark features consist of a leisure pool, lap pool, lazy river, slides, plunge pool, tot pool, deep well pool. Facilities were constructed in 2005 with the exception of the Flowrider. The features are in good condition, meeting expectations. Proper maintenance of the facility was observed. Features in the leisure pool were replaced in 2015.
- Minor concrete deterioration was observed under the lap pool gutter and deep well pool.

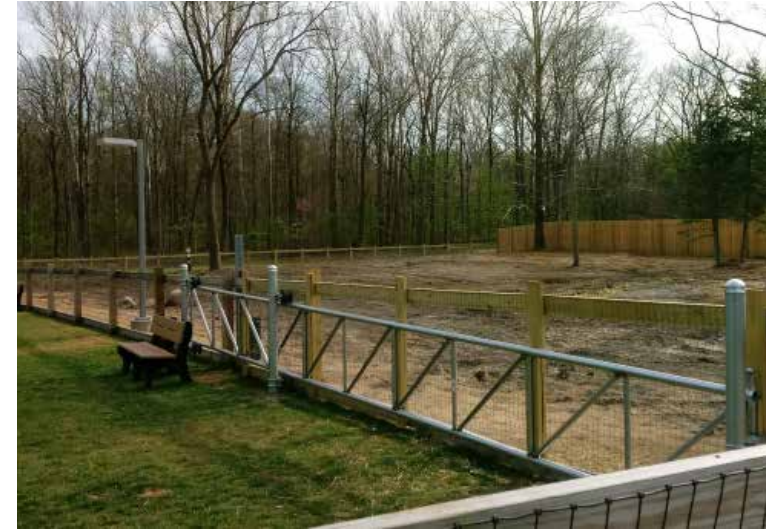
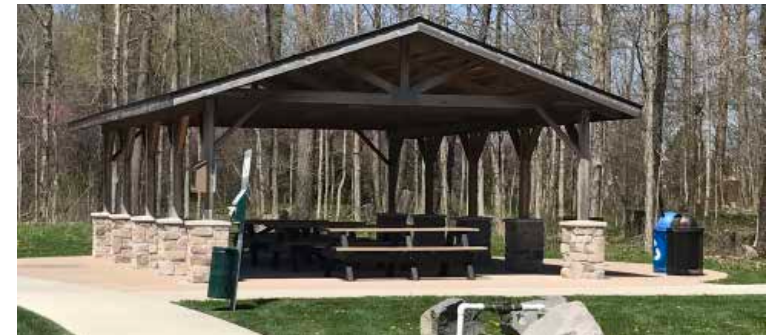
SITE ANALYSIS - DOG PARK

- The dog park is heavily used. Currently there is a waiting list for users. Expansion currently under construction will help meet the demand by community members.
- Parking lot utilizes permeable parking.
- Flexible use lawn, picnic shelter, and restrooms adjacent to dog park.
- The Dog Park shelter and exterior restroom are in good condition, exceeding expectations with continued maintenance. These structures were recently completed in 2017.

- Look to incorporate dog parks in other areas of Carmel-Clay park system.
- Rust staining was observed on the shelter stone due to iron deposits in the irrigation well water.

- Create trail connection to the main area of Central Park.
- Improve vehicle entrance to parking area. The existing turning radii is tight for most vehicles.
- Attach utility box to restroom facility and cover well utility structure.
- Overseed dog park lawn with fescue to establish a deeper-rooted turf system.

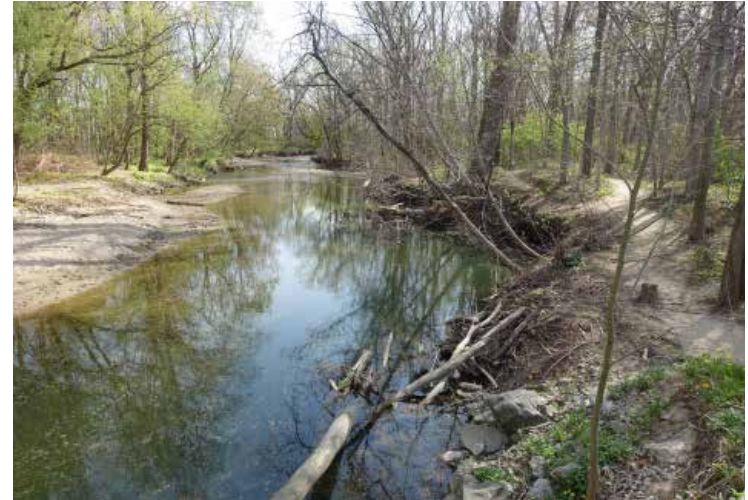
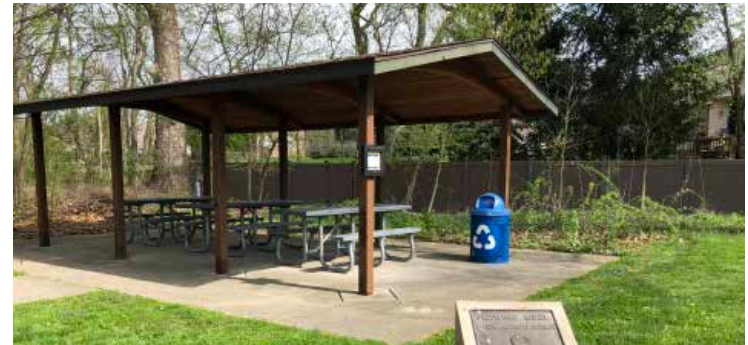
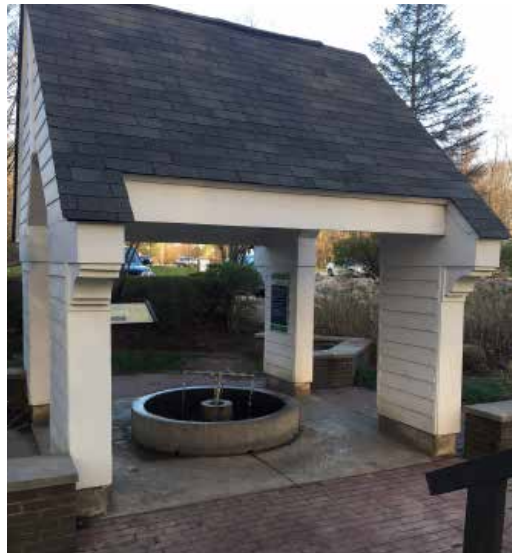
- Artesian spring is popular attraction for community members. Bottling of spring water is a common occurrence.
 - Natural trails along creek are well used and do not require surfacing. Bridges are in good condition

- Picnic shelter structure is in fair condition, meeting expectations. The wood roof structure is aging.
- Update entrance signage and trail map. Replace existing weathered interpretative signage throughout park.

- Anticipate a roofing replacement for both the well structure and shelter in the next 1-3 years.
 - Remediation of masonry seat wall at well structure is warranted.

- Regular maintenance is required on the structural steel at the shelter. Rusting was observed.

- Significant erosion of outer stream banks requires attention within the near future.
- Improve space surrounding the well and pedestrian access to limit cutting through landscape beds.

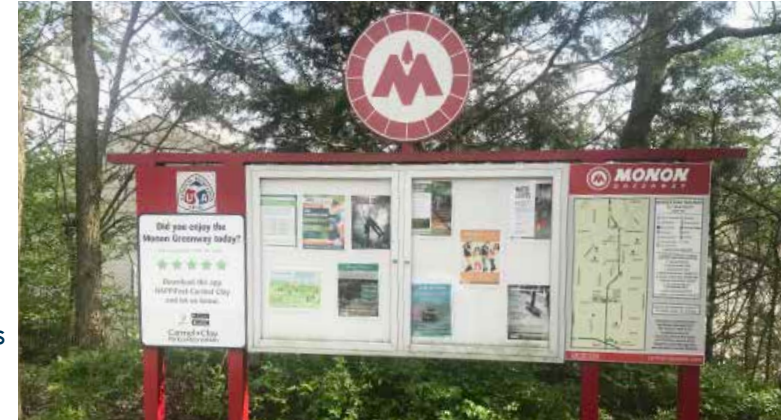
- Free parking is provided at each trailhead, as well as Carmel City Hall.
 - Clear signage and visual connection to trailhead from adjacent roadways.
 - Restrooms, drinking fountains, bike repair stations, and benches are provided at each trailhead.
 - Trailheads are well spaced along the greenway within the community.
 - The exterior restrooms were completed in January 2004. The structures are in good condition and exceed expectations with continued maintenance.
 - The shelter at the south trailhead is in fair condition, marginally meeting expectations.
- Minor staining was observed on the limestone base of the exterior restrooms at the north trailhead.
 - Rusting was observed on the doors of the exterior restrooms at both trailheads.
 - The roofing at the south trailhead shelter requires replacement. Severe rotting of the wood roof was observed.

- Improve connectivity to the Monon Greenway from downtown Carmel. Improve signage from intersecting roadways.
